Environmental & Engineering Geoscience

Stability and Collapse, Old Man of the Mountains, Franconia Notch, New Hampshire

BRIAN K. FOWLER

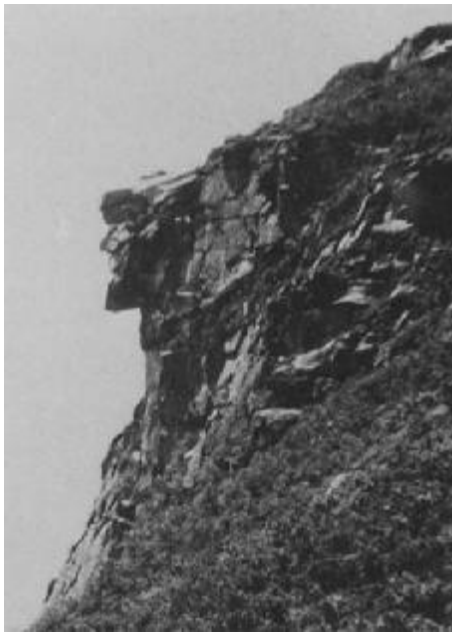
Figure 1. Old Man of the Mountains from Profile Lake, Franconia Notch. Viewpoint about 600 m (2,000 ft) north and 550 m (1,800 ft) below (photo by author, 1976).

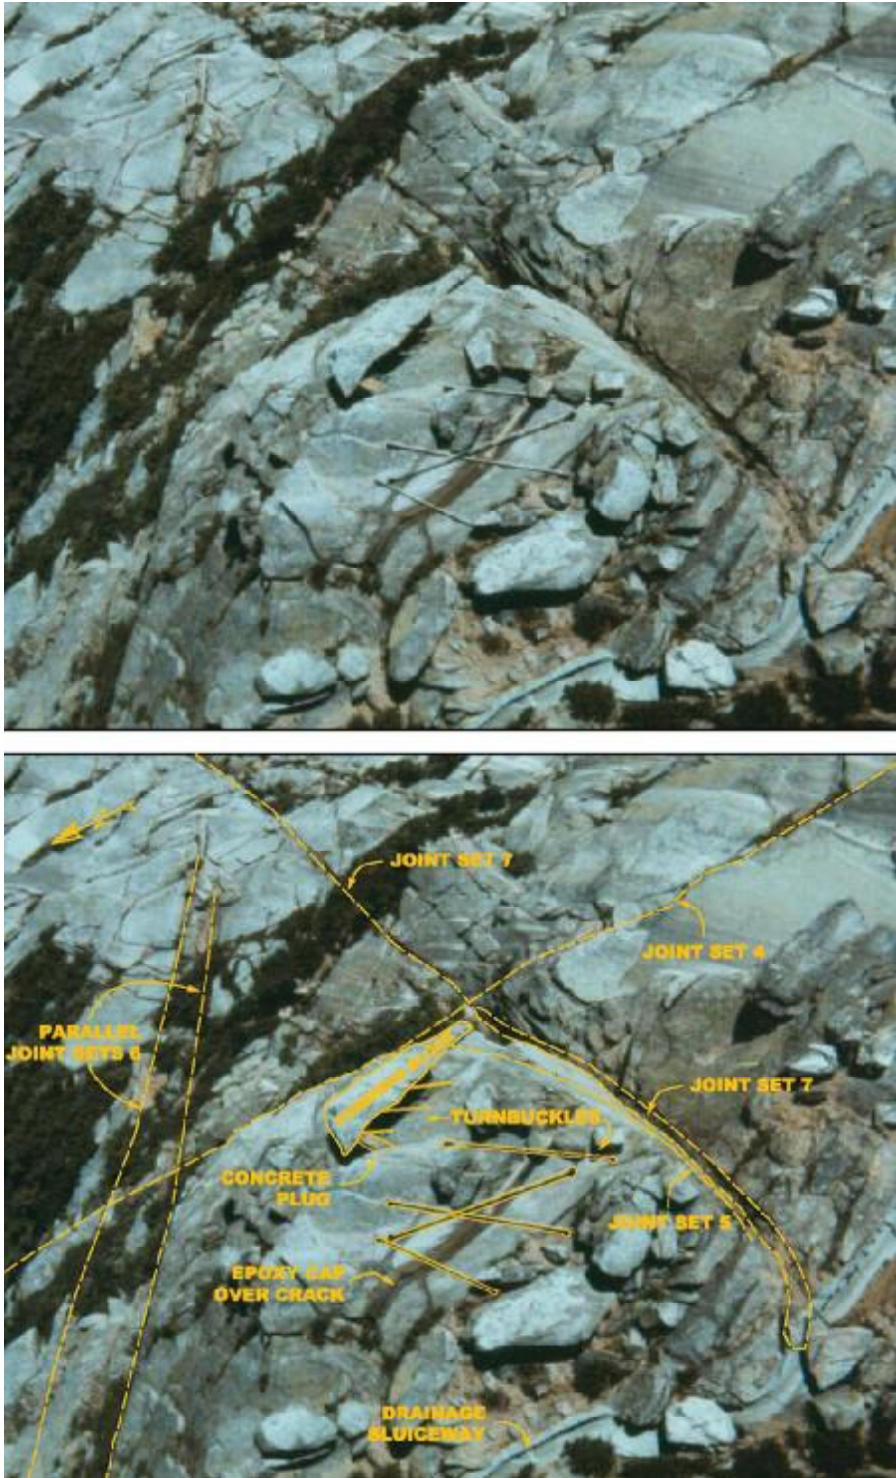
The Profile and each of the uniquely shaped blocks comprising it were formed by fortuitous weathering and selective breakage along five discrete sets of structural features (joints, fractures, and a shear zone) in its rock mass. Figures 2–5 and Table 3, respectively, illustrate and identify these features. Set 1 included all of the joints in sub-horizontal planes that cut through the rock mass and that were selectively fractured on their easterly edges to form the Profile view (Figure 2). Set 2 included the sub-vertical joints along which breakage had occurred to create the cliff face south of the Profile, while Set 3 included the sub-vertical joints along which the cliff was formed north of the Profile (Figure 3).

The significance of Set 7 in the formation of the Profile was most interesting (Figures 3 and 5). The faulted shear zone at the junction of the south face of the Profile and the cliff face and a similarly oriented zone about 15 m (50 ft) to the south (Figure 6) are major structural features in

the rock mass of the cliff. Shearing movement within Set 7 appears to have been a combination of linear and twisting displacements that resulted in a net rotation that, as can be seen in Figures 3 and 5, changed the orientation of the sub-vertical face-making joints north and south of the Profile from N20E to N35E (Sets 2 and 3).

Figure 3. Profile's rock mass from about 30 m (100 ft) overhead (top) and overlay view showing important structural geologic and man-made features (photos by D. Hamilton, 1976).

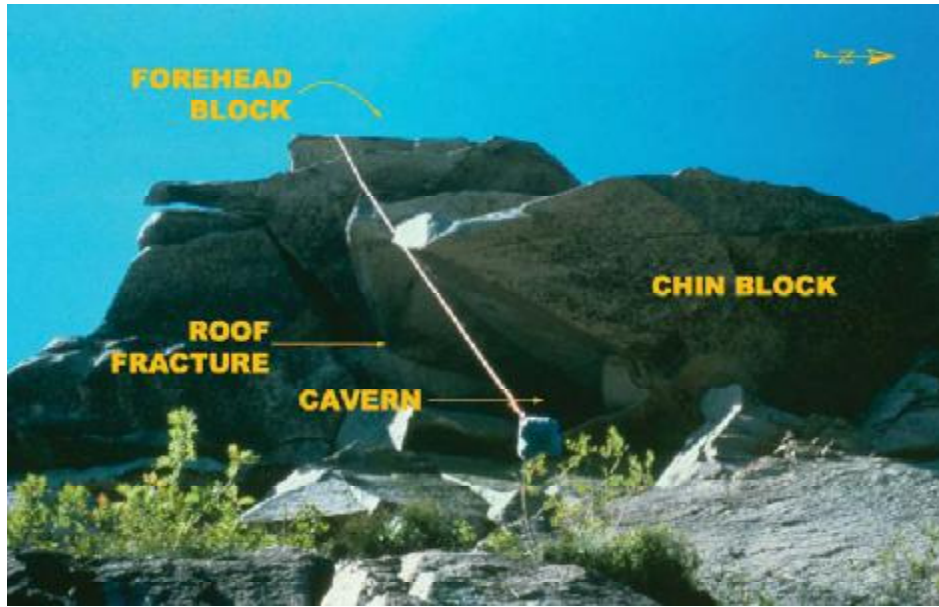
Figure 4. Profile's rock mass from about 25 m (82 ft) directly beneath (photo by author, 1976). Note location of the cavern and the fracture in its roof that separates the roughly triangular-shaped and delicately cantilevered chin and upper lip blocks from the rest of the rock mass.

of their comparatively broad flat blocks was greater than that of the more blocky, triangular, and extensively overhanging Blocks 4 and 5 below. These two blocks instead were cut off from the rest of the rock mass by the cavern and fracture extension behind them (Figures 4, 6, and 7) and thus appeared close to toppling collapse. If this were to occur, given their direct involvement with the likely foundation (point of bearing) of the composite rock mass, the subsequent toppling of Blocks 1–3 would quickly follow once their combined weight was unsupported from below.

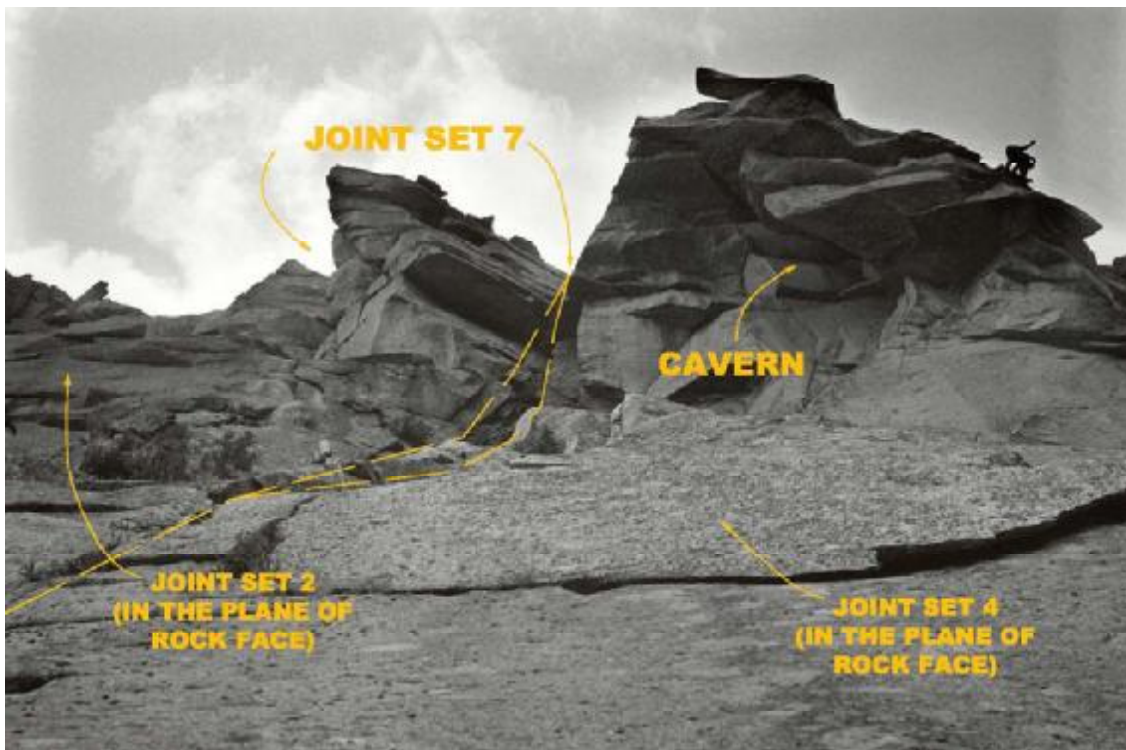
Figure 6. Profile's rock mass on the right (north) and adjacent rock mass on the left (south) showing location and influence of the two parallel Set 7 structures on block breakage patterns on the cliff (photo by S. Young, 1958).

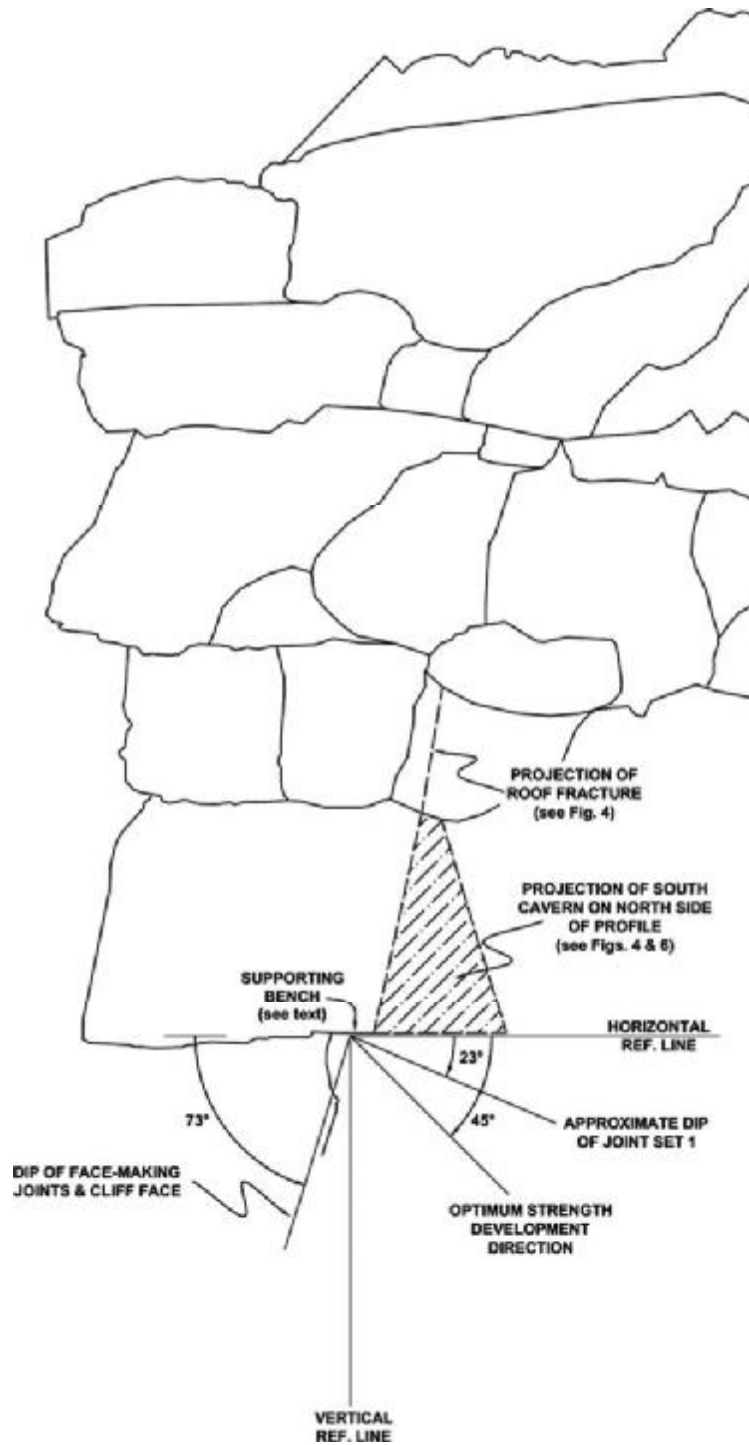
of bearing likely located beneath the supported portion of the chin, as illustrated in Figure 7. Thus, the Profile's composite rock mass was precariously cantilevered in position by its own dead weight. The security of this mechanism was, however, clearly delicate because of the very precariously cantilevered configuration of Blocks 4

First, based on the dimensional and spatial data and the rudimentary mechanical analysis, the cantilevering mechanism of the Profile's in-place stability was postulated as illustrated in Figure 7.

Figure 7. Estimated structural-mechanical relationships immediately beneath the chin.

The mechanism and sequence of the collapse can be reliably conceptualized by referring back to Figure 7, a sketch of the Profile's pre-collapse rock mass viewed from the north. Based on all that was known of its pre-collapse structure and the particular stability of its various parts, it appears the collapse likely occurred in two nearly simultaneous stages.

As described earlier, much of the roughly triangular chin and upper lip block combination overhung the cliff below and was held in position by the weight of the three blocks above cantilevering the rearward triangular point of their combined mass onto the cliff at a point of bearing in the narrow granite bench below, located just in front of the cavern (Figure 7). Based on the surficial deterioration observations of 1985–1986, the extent of internal deterioration revealed by the collapse, and the fact that only incipient construction-related vibration reached the rock mass during I-93 construction, it appears that the naturally progressive processes of kaolinization decomposition and vigorous freeze–thaw degradation reduced the intact

strength of the granite in the narrow bench and gradually weakened it sufficiently so it could no longer remain intact. When this foundation suddenly disintegrated, the chin was no longer supported and toppled forward and downward, taking the upper lip and the rest of the rock mass above with it as the blocks broke off along the joints bounding them to the rear (Figure 7, fracture extension).

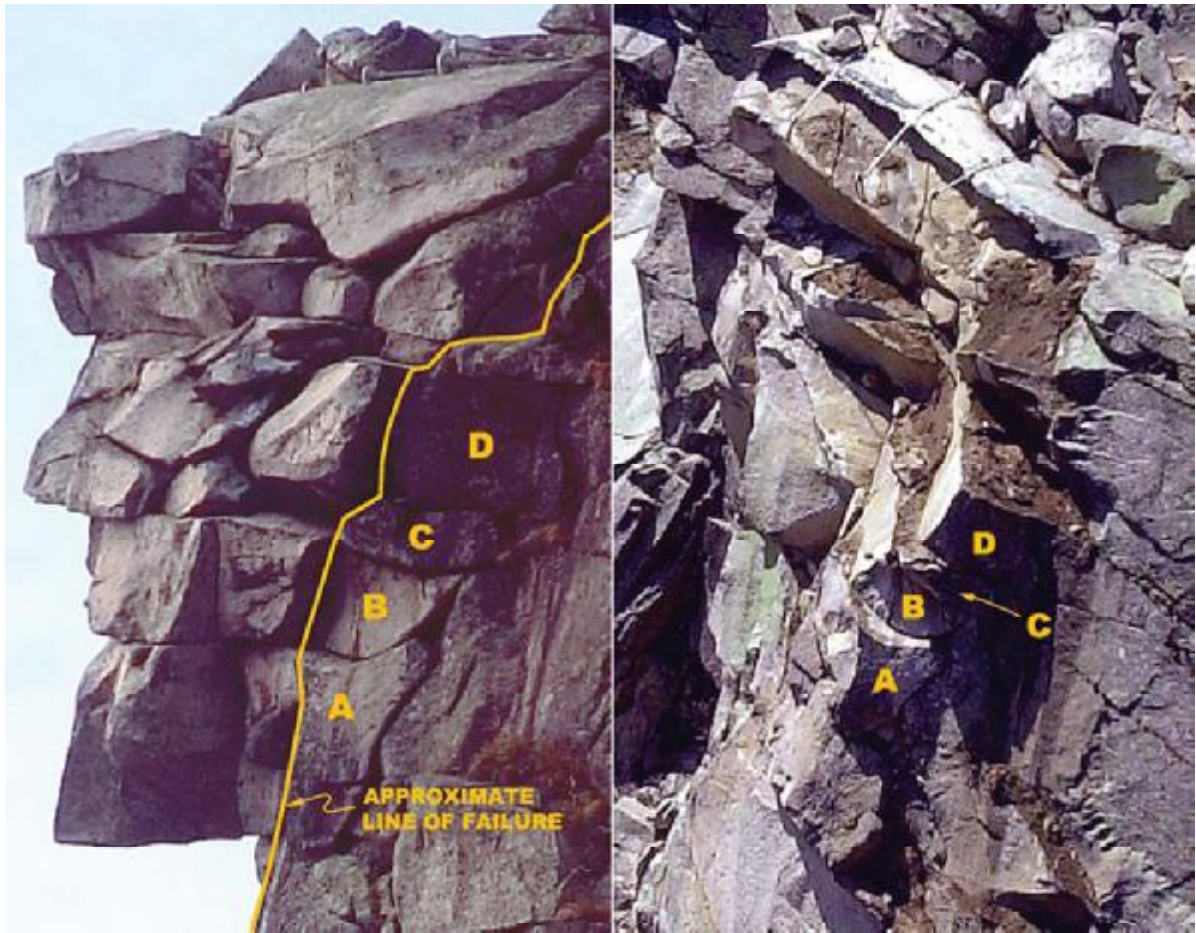
immediately by careful comparison of photographs. The best of these comparisons are presented in Figure 8. These views, before and after collapse, respectively, permit fairly precise determination of what portions of the rock mass collapsed. The blocks marked A through D in both photographs show clearly that the chin and upper lip block combination fell away from the joints separating them from blocks A and B, and the failure line on Figure 8 shows the approximate back line of the blocks and portions of the rest of the blocks that collapsed. All portions of the original composite rock mass collapsed except for the rear portion of the forehead slab.

Figure 8. Profile's rock mass before and after collapse, showing extent of toppling failure. Note forehead turnbuckles in both views (photo at left by J. Cole, Associated Press, 2001; photo at right by Union Leader Corp., 2003).

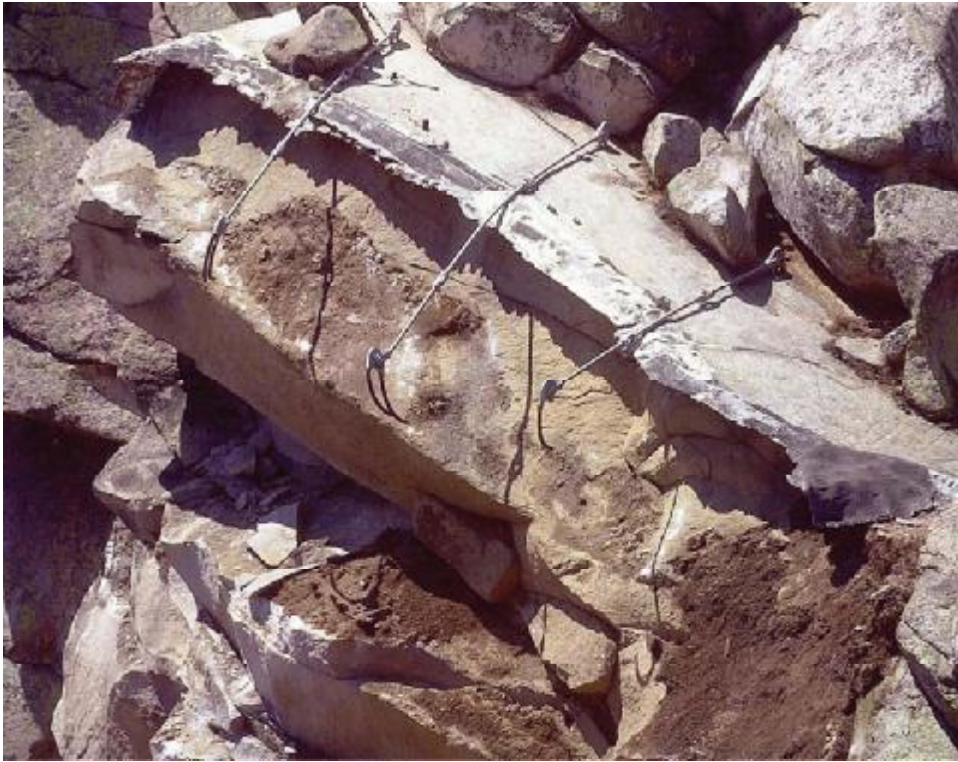
Figure 9 is a view of the top of the residual rock mass showing the un-collapsed rear portion of the forehead slab, into which the large stapled turnbuckles had been installed (Table 2: 1958) along with the residual rock mass below. The backward-curved pattern of deformation of the forward staples that were stripped out of the front portion of the forehead as it moved away indicates the rock mass toppled forward rather than sliding downward. Had sliding occurred, these staples would have been curled in the opposite direction and the line of breakage behind the Profile would not have been left as cleanly defined.

The toppling failure mechanism is also documented by the significant accumulations of weathered granite grus visible on the residual ledges below the residual forehead slab. These volumes of grus, formed by kaolinization weathering of the granite between joint surfaces within the rock mass before its collapse, are surprising given the extensive surficial efforts over the years to prevent such weathering by rain, meltwater, and wind-driven cloud water (Table 2: 1958). Had a sliding failure occurred, these loosely granular accumulations of grus would have been swept away with the collapse.

Figure 9. Close-up, top of the Profile's residual rock mass (photo by Union Leader Corp., 2003).
