Environmental & Engineering Geoscience

Stability and Collapse, Old Man of the Mountains, Franconia Notch, New Hampshire

BRIAN K. FOWLER

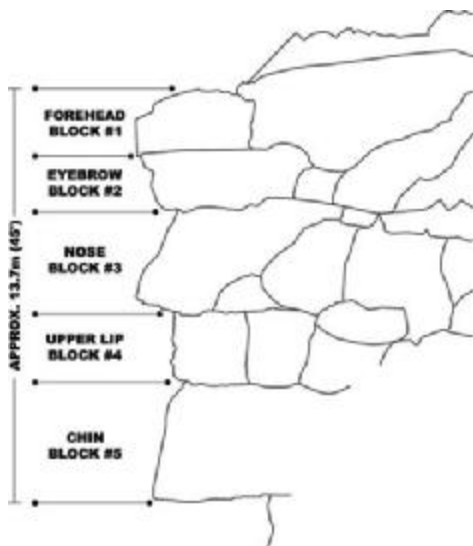
Figure 2. Diagram of Profile's component block combinations.

The Profile and each of the uniquely shaped blocks comprising it were formed by fortuitous weathering and selective breakage along five discrete sets of structural features (joints, fractures, and a shear zone) in its rock mass. Figures 2–5 and Table 3, respectively, illustrate and identify these features. Set 1 included all of the joints in sub-horizontal planes that cut through the rock mass and that were selectively fractured on their easterly edges to form the Profile view (Figure 2). Set 2 included the sub-vertical joints along which breakage had occurred to create the cliff face south of the Profile, while Set 3 included the sub-vertical joints along which the cliff was formed north of the Profile (Figure 3).

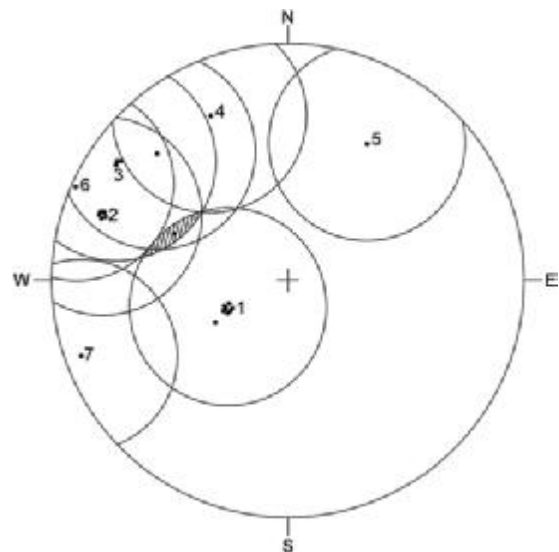
Figure 5. Pole diagram of structural features (lower hemisphere). Set 1, sub-horizontal joints through Profile's blocks. Sets 2–7: sub-vertical joints defining the cliff face south of the Profile (2), the cliff face north of the Profile (3), the cut-off joint east of Blocks 2–5 (4), the south face of the Profile (5), the north face of the Profile (6), and the shear zone south of the Profile's rock mass (7).
